**DYNAMIC TESTING OF A COMPOSITE MATERIAL
HELICOPTER TRANSMISSION HOUSING**

Bell Helicopter Company

**Army Air Mobility Research and Development
Laboratory**

September 1975

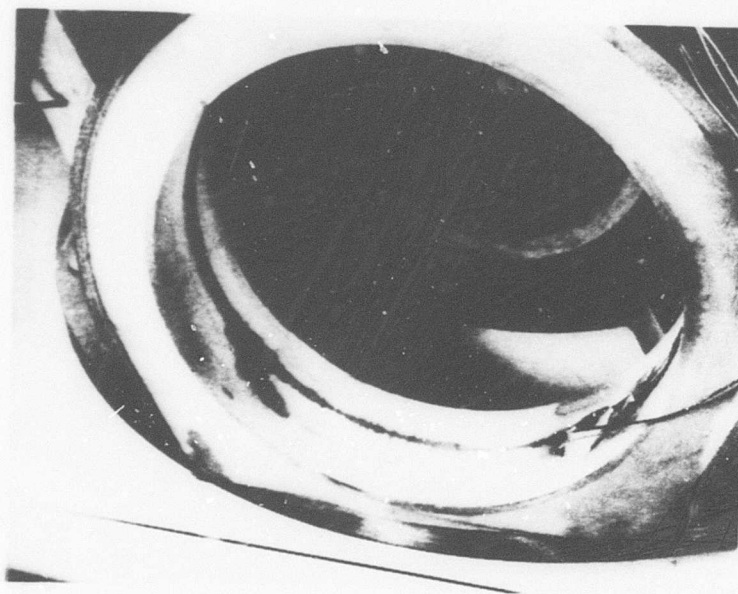
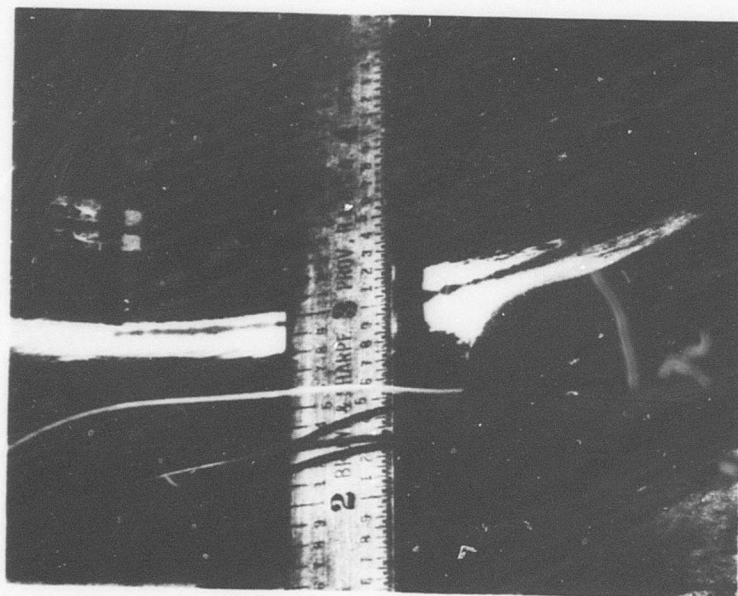
Figure 8. Crack in the Input Quill
Bore of S/N 1 Housing.

Figure 9. Close-up of Crack in the Input
Quill Bore of S/N 1 Housing.

cracked. The cracks in the input and accessory quill bores were located approximately in the same plane as the intersection of the housing cylindrical wall and the quill bores. It is possible that a thermal expansion differential between the housing wall and the quill bores could have caused the graphite liners to crack. As shown in Figures 12 and 13, the graphite liner in the bore for the input gear roller bearing was severely cracked. These cracks could possibly have been caused by a thermal expansion differential between the graphite liner and the surrounding nine webs.

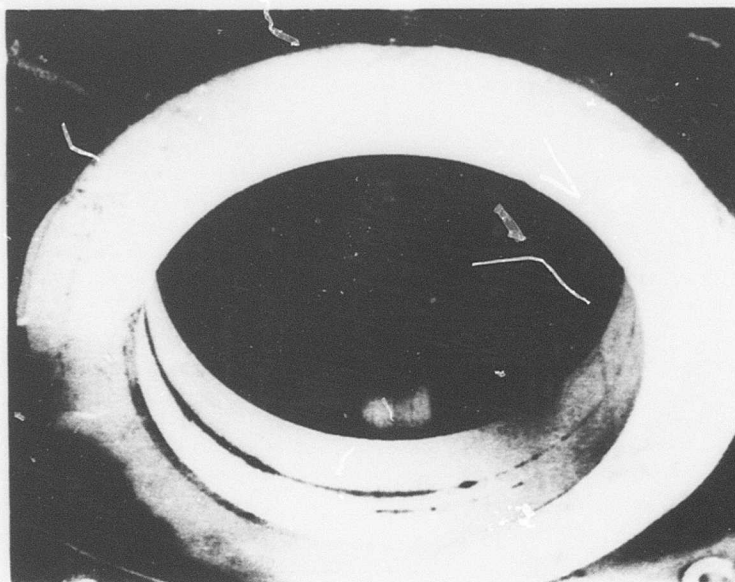
Figure 10. Crack in the Left-Side Accessory Bore of S/N 1 Housing.

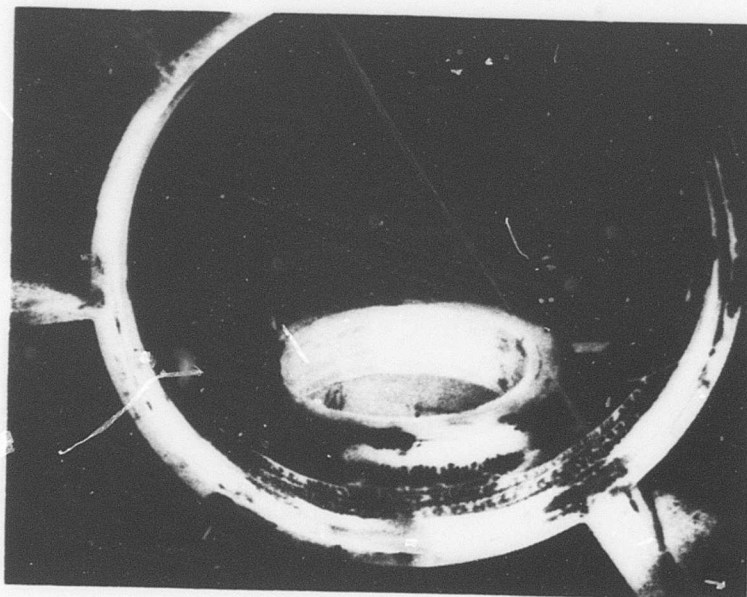
Two strain gages in a circumferential direction and one in the axial direction were bonded in each bore except the input gear roller bearing bore. Only one gage in the circumferential direction could be bonded in the input gear roller bearing bore due to the numerous cracks.

Figure 12. Cracks in the Input Gear Roller Bearing Bore of S/N 1 Housing.

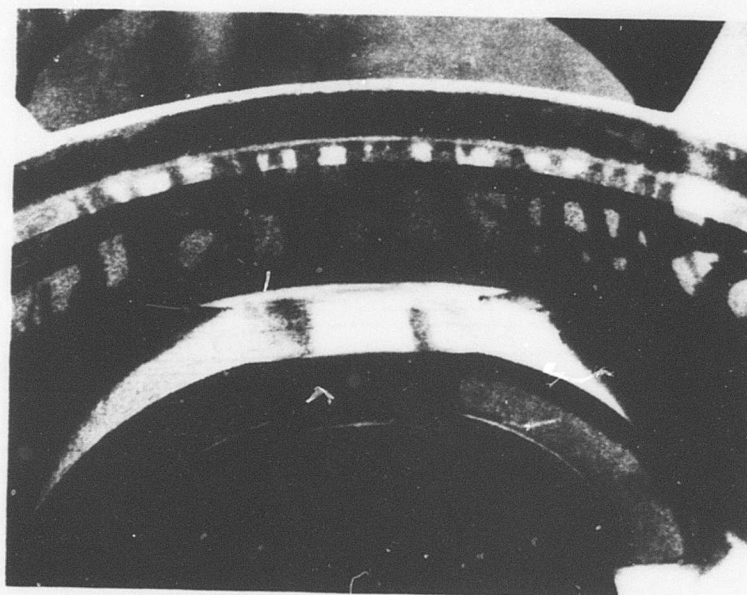
Figure 13. Cracks in the Input Gear Roller Bearing Bore of S/N 2 Housing.

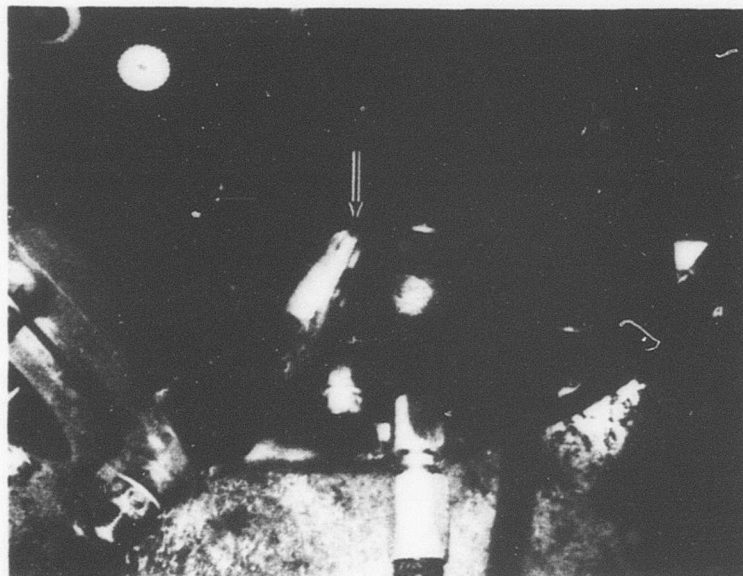
Operation during the initial step revealed excessive leakage of oil through bond voids and cracks around the input quill bore. The leaks were serious enough to prevent further use of the housing unless it could be sealed. USAAMRDL requested BHC to attempt to seal the housing so that the bench test program could be conducted.

The housing was twice sent through a vacuum impregnation process per Bell Process Specification (BPS) 4432. The vacuum impregnation process uses a thermosetting polyester resin of low viscosity designed specifically for impregnation of porous magnesium and aluminum transmission housings. The housing was then pressure tested as shown in Figure 20 without reassembling in a test transmission. The impregnation process had no appreciable effect on the oil leaks, and additional leaks were discovered inside the housing around the input quill bore. Figures 21 through 23 show the location of the leaks.

Figure 21. Oil Leak Adjacent to Oil Manifold Pad After Vacuum Impregnation.

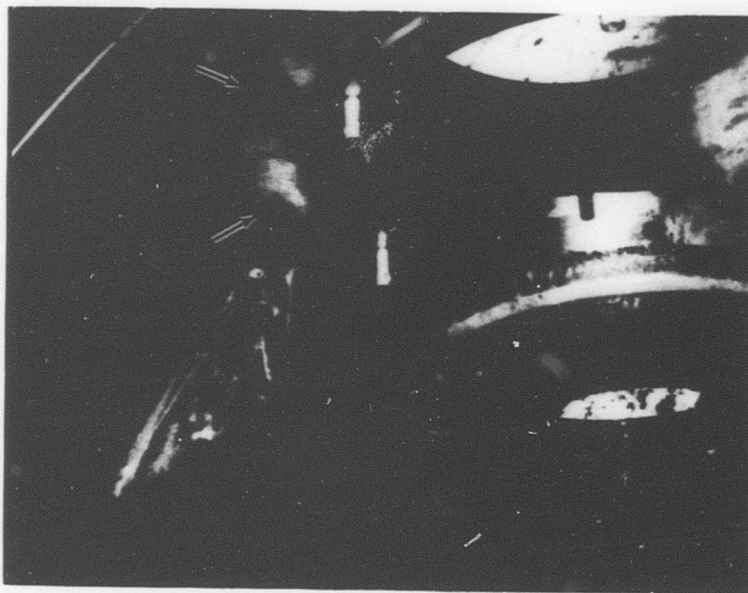
Figure 22. Oil Leak Coming From the Main Bearing Ring-to-Housing Bond After Vacuum Impregnation.

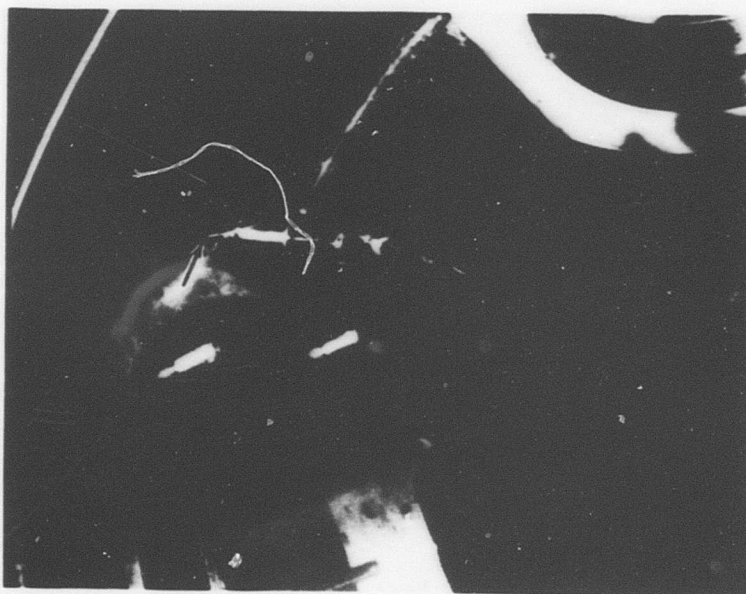
Figure 23. Oil Leak Near the Input Pinion/Gear Mesh Oil Jet After Vacuum Impregnation.

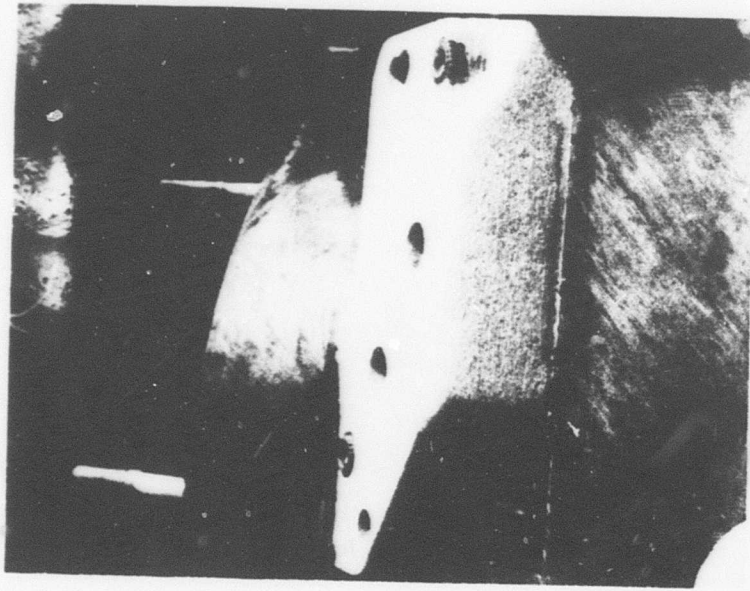
An additional problem, discovered during the pressure test, was the failure of the threads for the inserts in the oil manifold pad. The failure of the threads in the bulk molding

compound (BMC) was not unexpected since the BMC has only 49 and 25 percent of the shear strength of the magnesium housing at 70°F and 350°F, respectively. The failed threads were repaired by laying on Hysol Dexter EA-934, retapping, and installing inserts with 35 percent more shear area.

While the housing was being cleaned prior to the second sealing attempt, it was mistakenly immersed in the trichloroethylene of a vapor degreaser for 2 hours. Some visible damage to the housing occurred. As shown in Figures 24 and 25, flaking from the surface of the BMC occurred. Most of the flaking came from the BMC that was added to the housing by its manufacturer to correct deficiencies so that the housing could be machined to blueprint specification. The damage was minor, and no repairs to the BMC were necessary.

Figure 24. Flaking From BMC Oil Manifold Pad and Thread Failures.

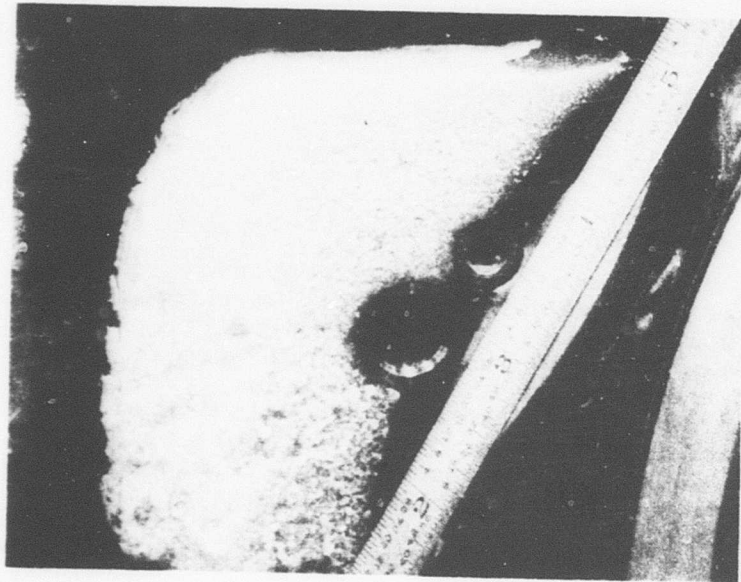
Figure 25. Flaking From BMC Oil Jet Pad for Input Pinion/Gear Mesh Oil Jet.

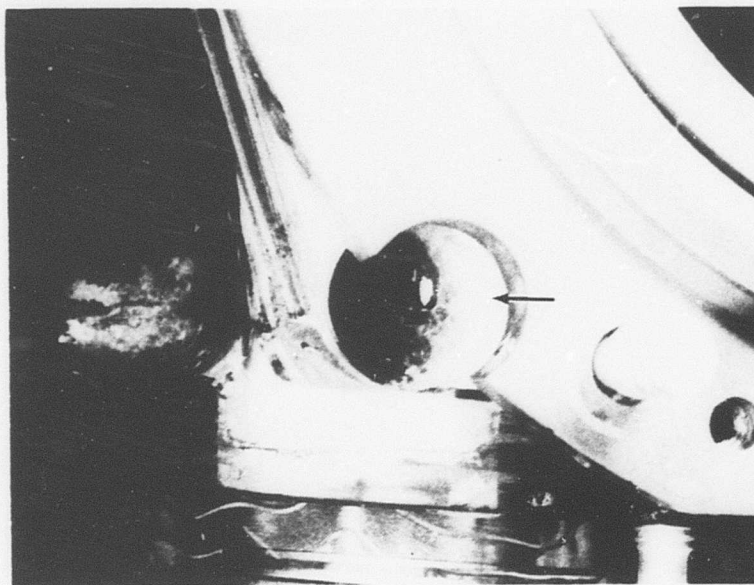
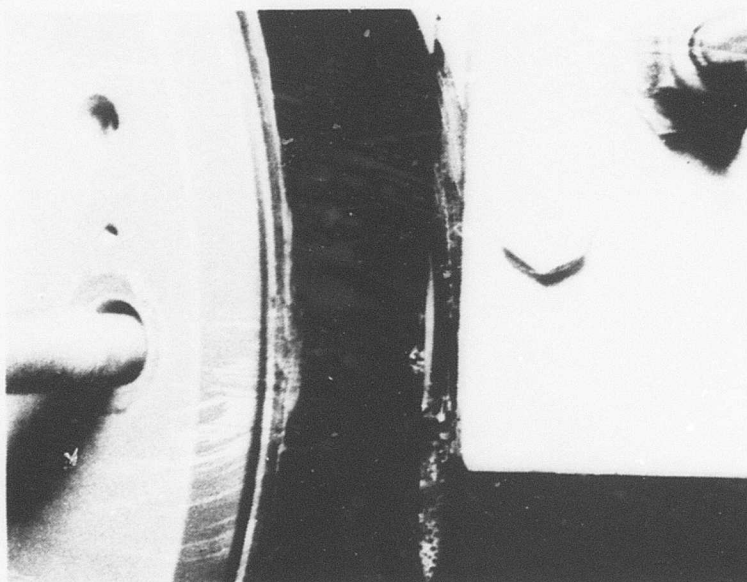
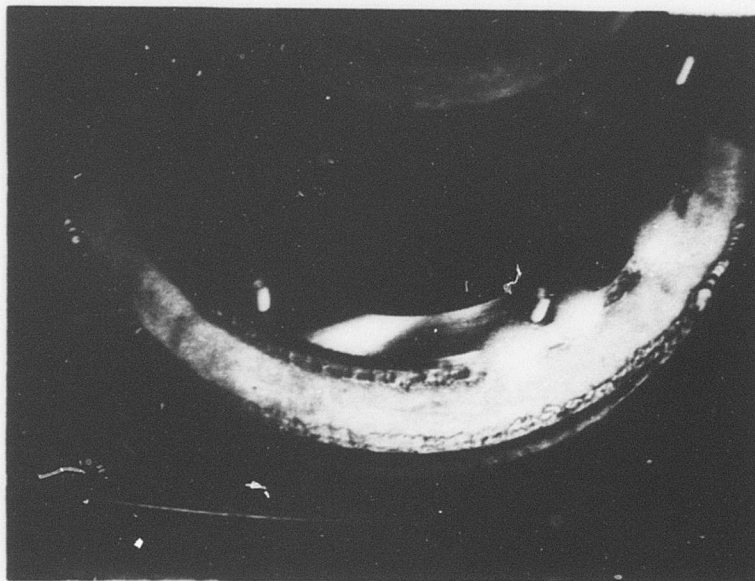
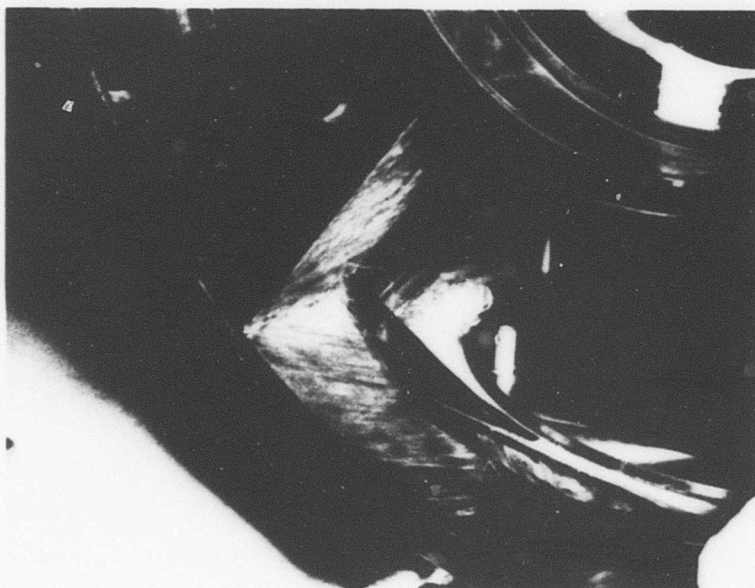
After the housing was sealed with the fluorinated silicone, it was pressure tested using 60-psi air and soapy water brushed onto the housing surface. The pressure test revealed that the housing still had some small leaks as shown in Figures 26 through 29. However, the leaks were not serious enough to prevent resumption of the spiral bevel gear development test.

Figure 26. Leak in Oil Transfer Tube Bore After Sealing With Fluorinated Silicone.

Figure 27. Leak Adjacent to Oil Manifold Pad After Sealing With Fluorinated Silicone.

Figure 28. Leaks From Main Bearing Ring Near Top of Housing After Sealing With Fluorinated Silicone.

Figure 29. Leak From Main Bearing Ring Near Bottom of Housing After Sealing With Fluorinated Silicone.

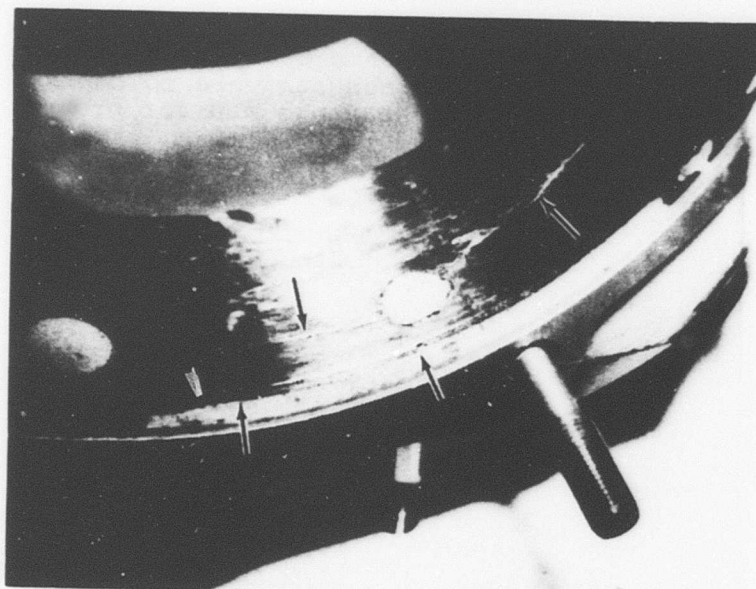
The removal and installation of the input quill after each step resulted in the filament-wound carbon-epoxy liner in the input bore splintering as shown in Figure 36. The damaged liner was repaired with Ren Plastic, Inc. RP-1220 epoxy.

Figure 36. Splintering of Filament-Wound Carbon-Epoxy Liner in Input Quill Bore.

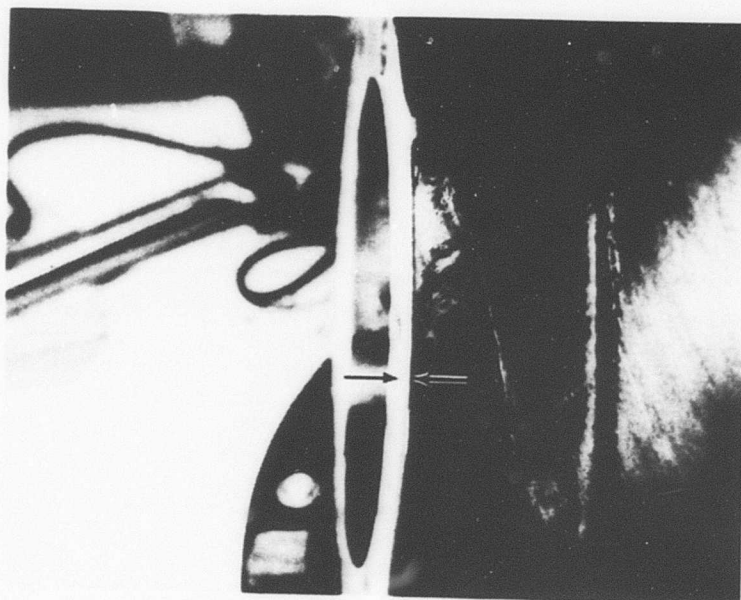
As shown in Figure 37, the BMC bearing ring for the forward accessory bore pulled out of the housing approximately .05 inch. The ring-to-housing bond apparently failed. It is not known whether the installation of the offset generator quill during assembly or the vibration during the test caused the failure. The BMC ring around the quill was not carrying any load during the test since the gear was removed from the quill. No repairs were attempted since the failure did not prevent further use of the housing.

Figure 37. Pullout of Forward Accessory Bore BMC Bearing Ring.

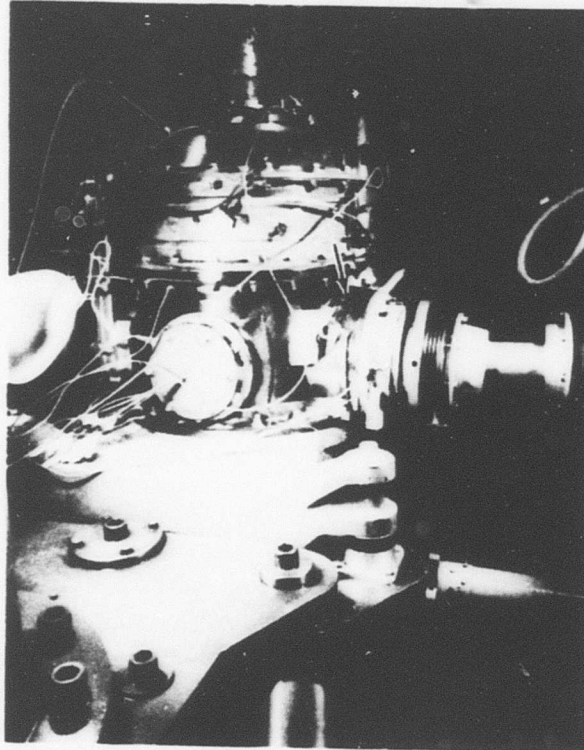
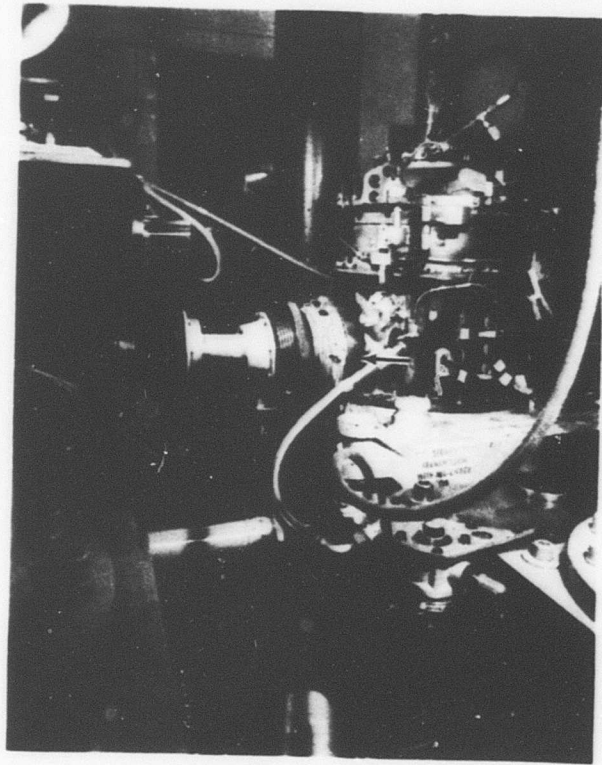
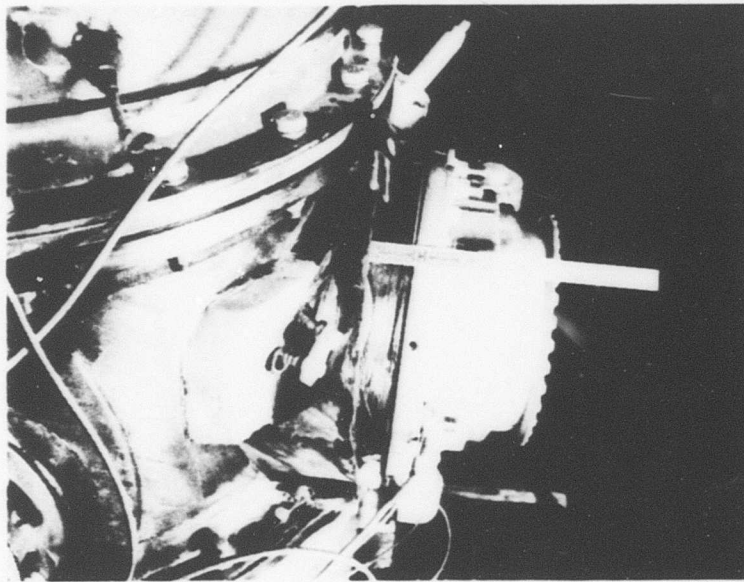
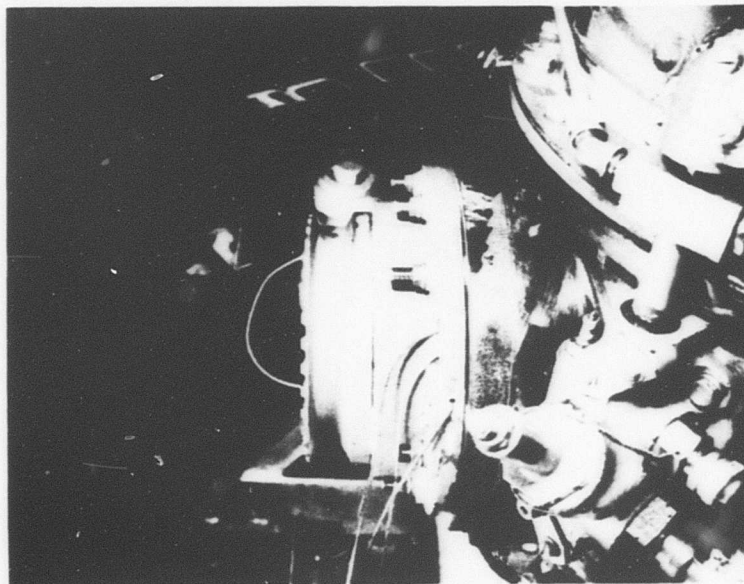
After completion of a 10-minute warm-up the following morning, the load was gradually being increased to the torque specified for Step 14. At a load of approximately 1002 mast horsepower and 75 tail rotor horsepower, the input quill area of the composite housing structurally failed. The axial load acting on the input quill at failure was approximately 3600 pounds. As shown in Figures 38 through 41, the input quill was pushed approximately .8 inch out of the housing, allowing the input pinion and gear teeth to disengage. As shown in Figures 42 through 49, the composite housing was damaged beyond repair. Figures 42 and 43 provide orientation for Figures 44 through 49.

Figure 38. Left-Side View of Transmission
After Failure of Composite Housing.

Figure 39. Right-Side View of Transmission After Failure of Composite Housing.

Figure 40. Left-Side View of Composite Housing After Failure.

Figure 41. Right-Side View of Composite Housing After Failure.

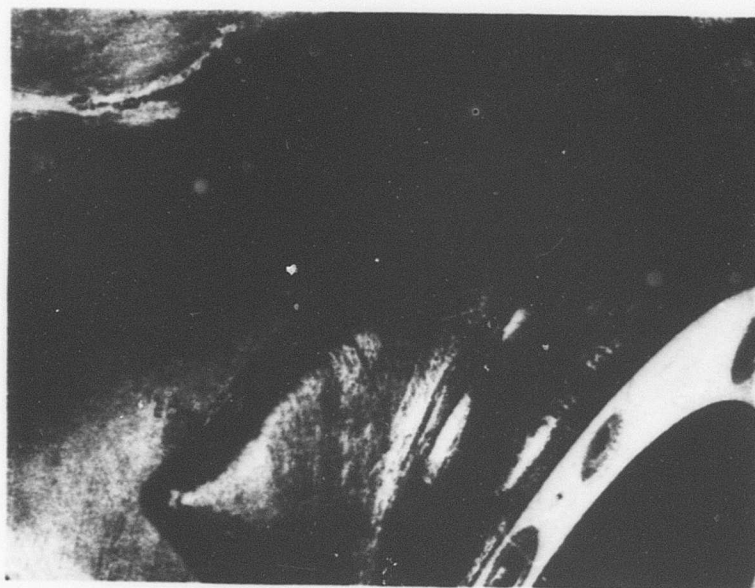
Figure 45. Tear Located on Left Side of Input Bore of Composite Housing After Failure.

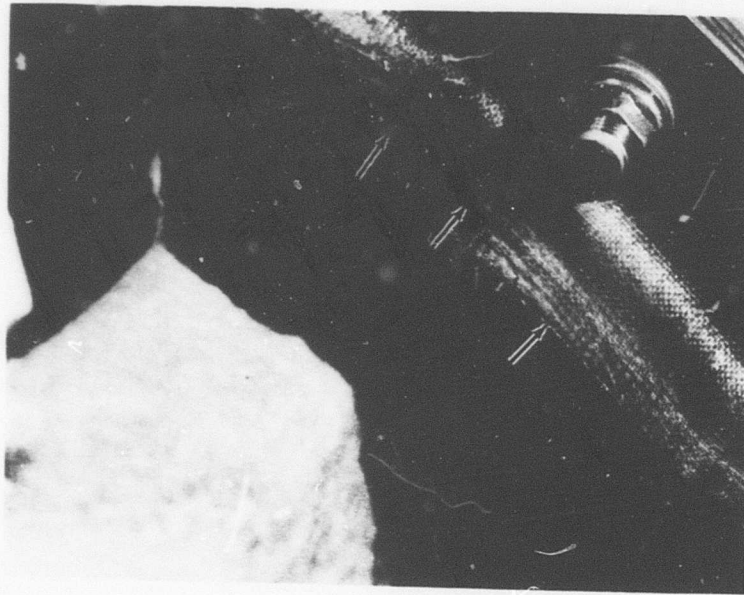
Figure 46. Crack Near Bottom Flange of Composite Housing After Failure.

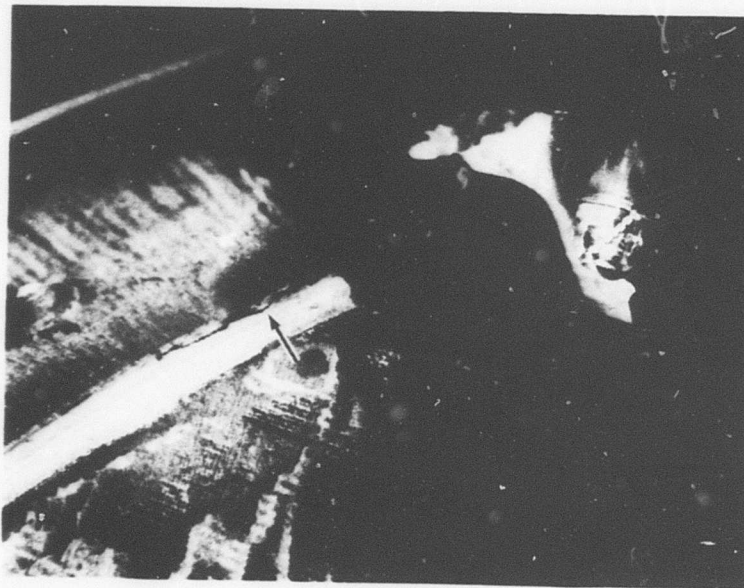
Figure 47. Crack in the Input Pinion Roller Bearing Web-Housing Bond After Failure, Right Side.

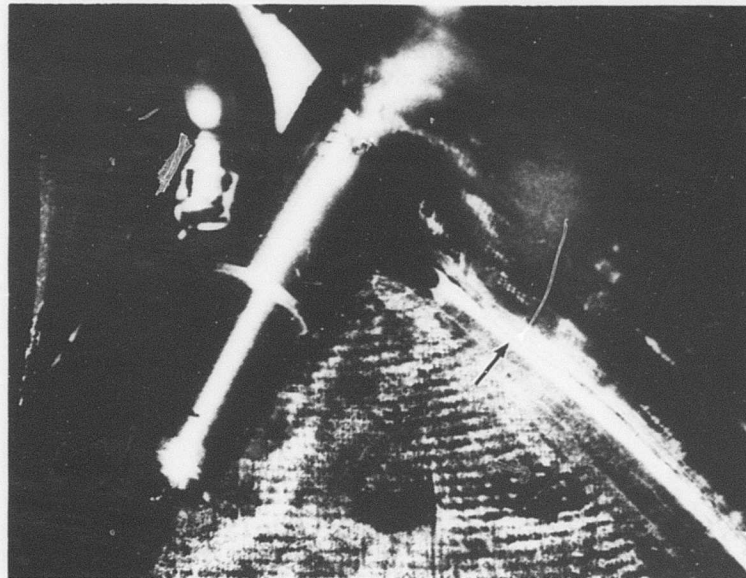
Figure 49. Crack in the Input Pinion Roller Bearing Web-Housing Bond After Failure, Left Side.

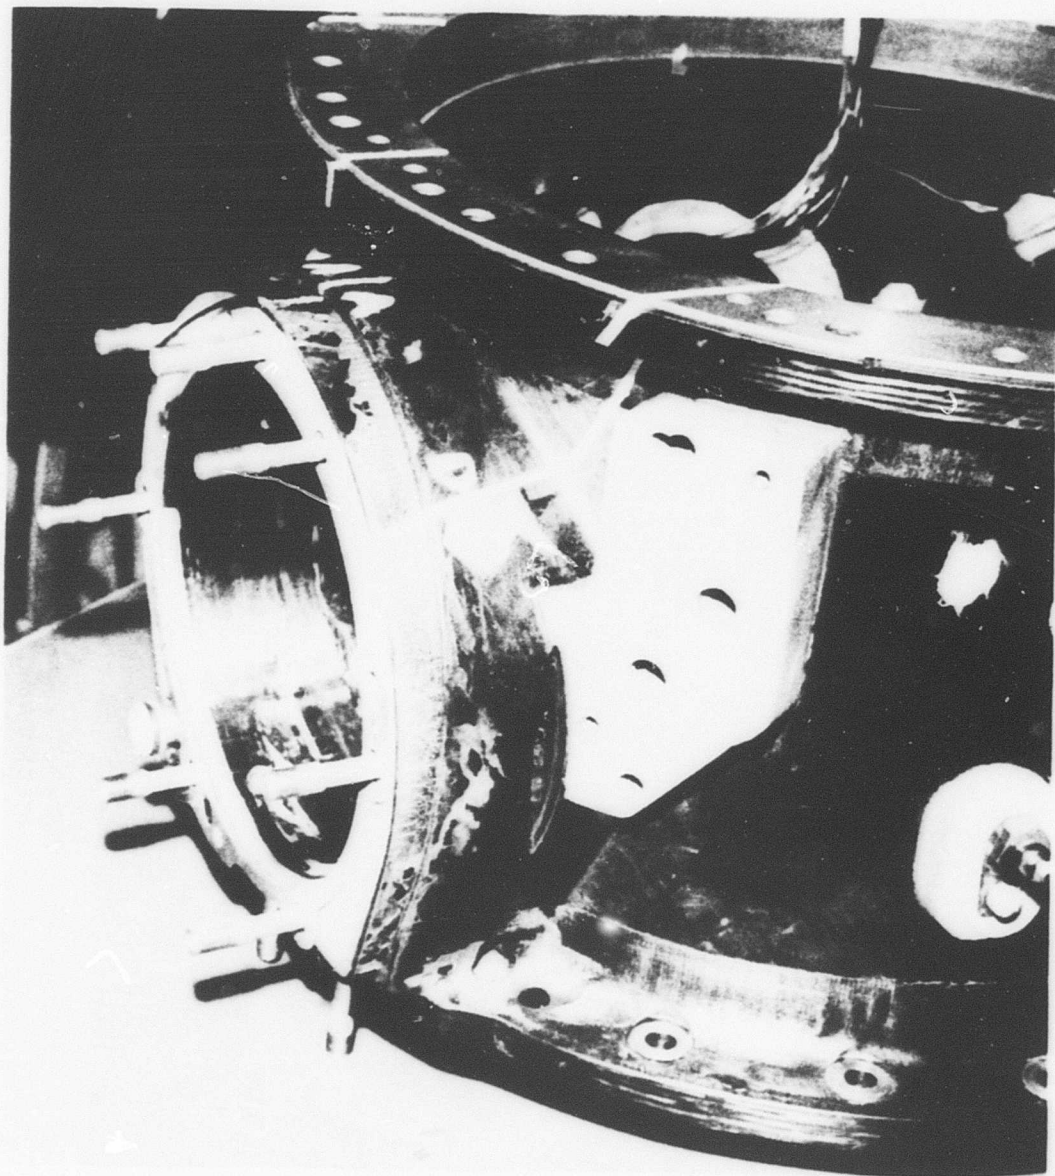
5. The failure analysis showed that the structural failure of the input quill area of the composite housing was the result of a defective main bearing ring-to-housing bond.

Visual inspection of the failed housing suggested that the failure was probably caused by a faulty bond between the body of the housing and the main bearing ring. Figure 50 shows that the bearing ring pulled out from the housing, the bond material adhered to the bearing ring, and the top of the ring pulled away more than the bottom. The amount of separation varies almost linearly from top to bottom, implying that the origin of failure was at the top. If the applied thrust load had been distributed uniformly around the face of the bearing ring (approximately equal tensile load on each of the 7 mounting studs) at first, then as the top pulled away the lower studs would have become more heavily loaded and the ring would have been loaded in bending perpendicular to its plane. Eventually, this would have caused a failure in combined bending and tension near the bottom of the bearing ring. This failure did in fact occur and is visible in Figures 51 and 52.

Figure 50. Side View of Failure Showing Bearing Ring Pulled Away From Body of Housing.

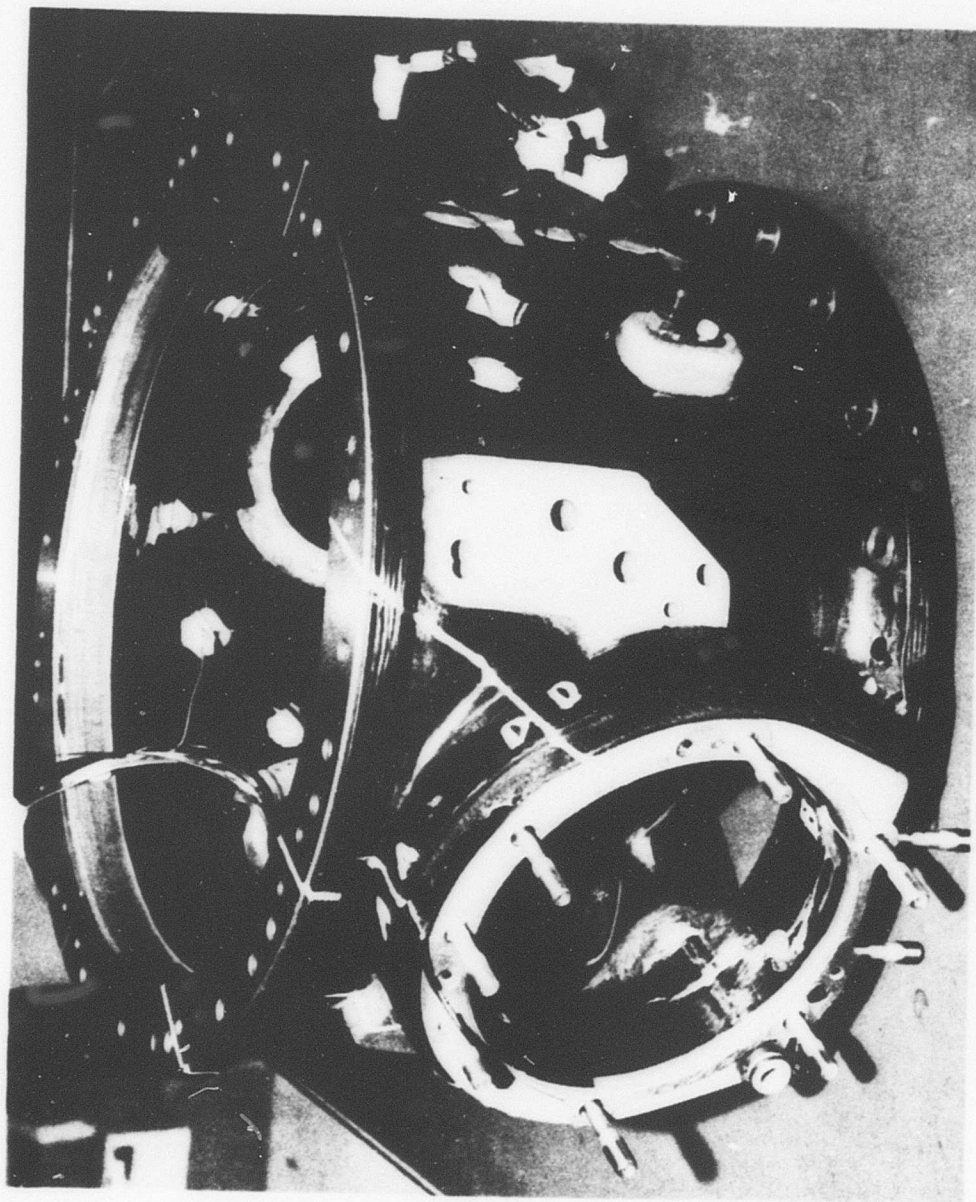
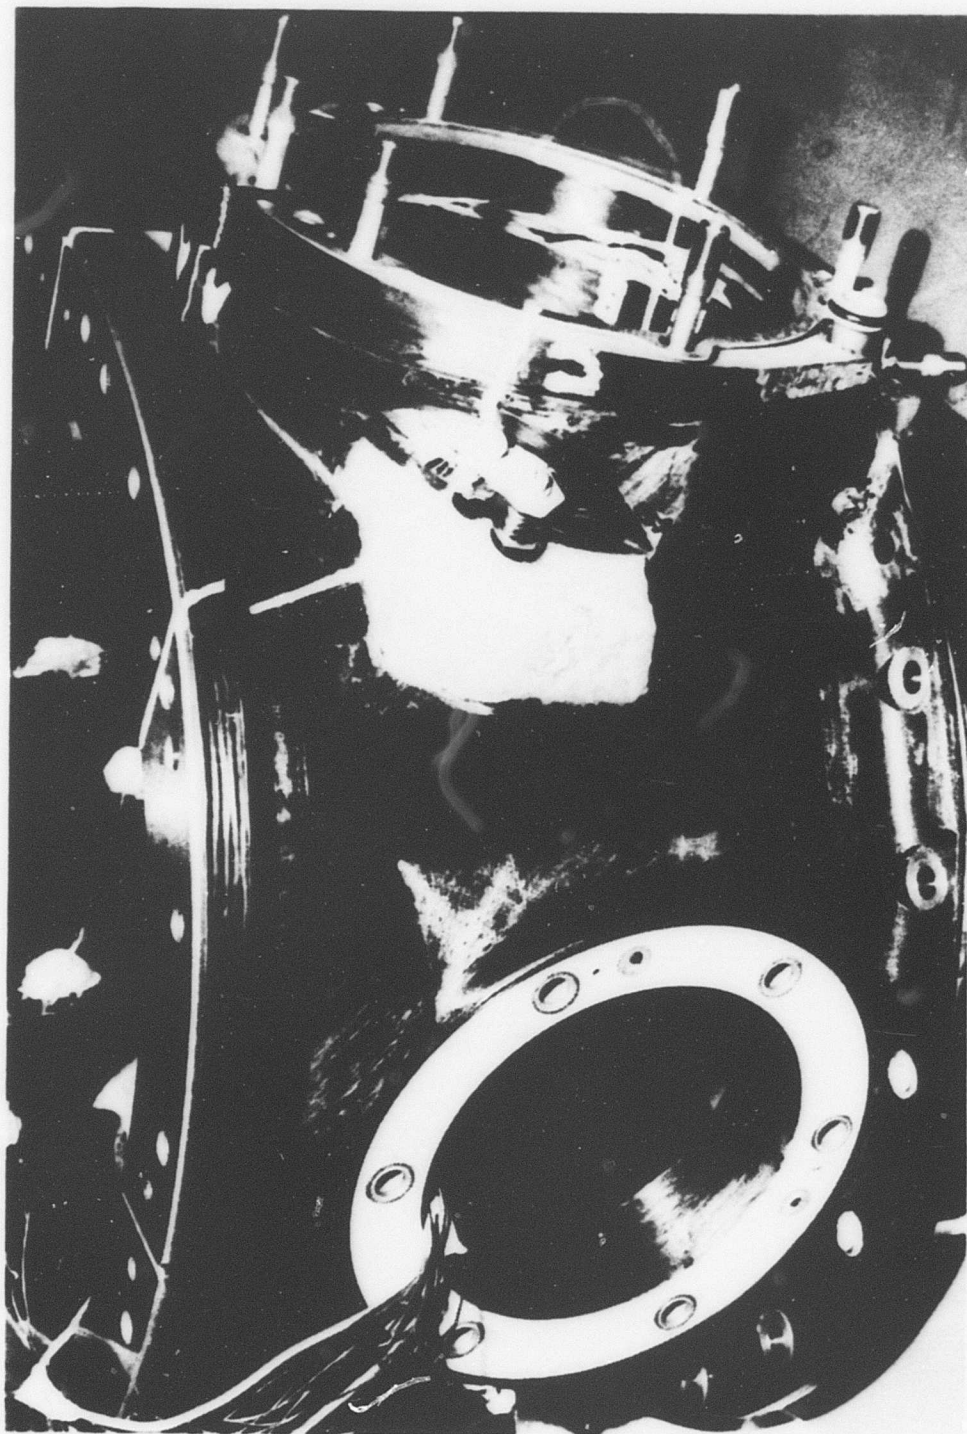
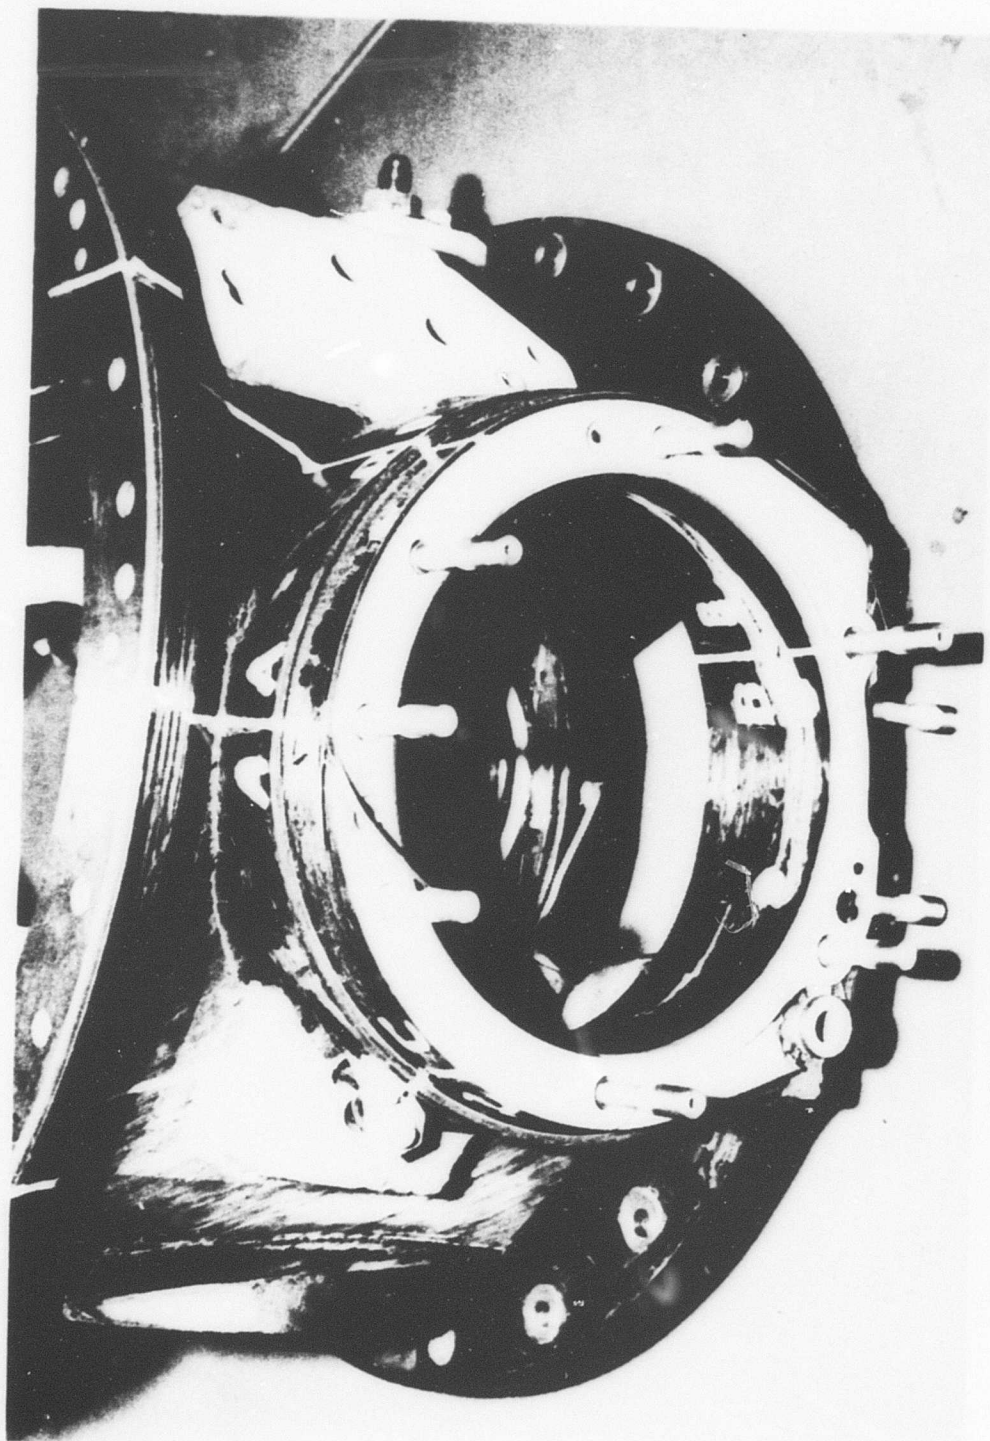
Figure 51. Forward View of Failed Housing Showing Locations at Which Sections Were Cut.

Figure 52. Side View of Failure Showing Locations of Sections A-A, B-B, and C-C.

Figure 53. View Showing Failure at Lower
Portion of Main Bearing Ring.

It was virtually impossible to obtain a full set of accurate dimensions on the main bearing ring because the failure had weakened it and the inner ring fell apart when the sections were cut. However, some measurements were made between Sections A-A and D-D as shown in Figure 53. The fore and aft dimensions in line with the thrust load varied from 1.88 to 2.11 inches, as compared with a specified dimension of 2.12.

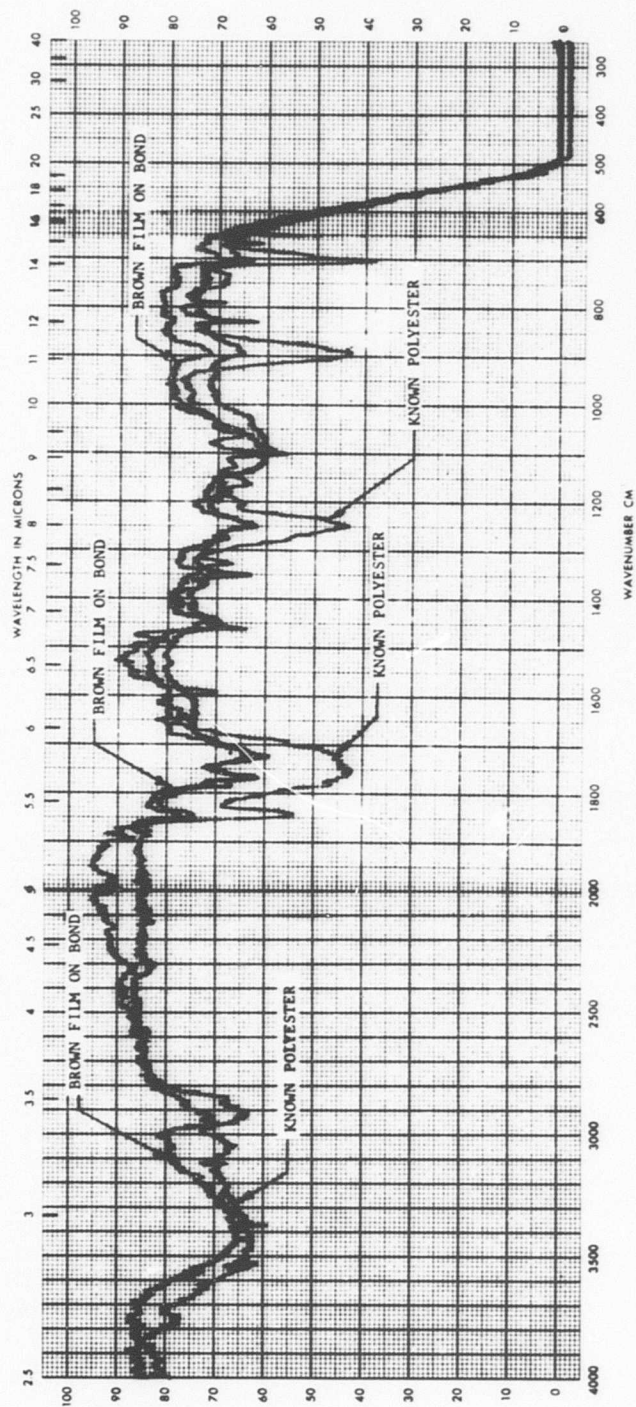
The IR spectral photometer verified the results obtained with the electron beam microscope, and added one important piece of information: the brown film found on approximately 15 percent of the adhesive surface was a polyester material. Figure 54 shows the traces of the comparison of the brown film with a known polyester. The two materials follow each other closely throughout the range of wavelengths tested. Since a polyester material was used to impregnate the housing at 85 to 100 psi

Figure 54. Infrared Spectral Photometer Traces Showing Comparison of Brown Film Found on Bond Surface With Known Polyester Material.

pressure, this must have been deposited during the impregnation cycle. The polyester would have penetrated such a large area of the adhesive only if there had been large voids in the bond.
